**ASSESSMENT REPORT FOR DRAFTING OF  
BOQ FOR THE REPAIRS OF PERMANENT ROOF LEAKS FOR THE  
ASSESSMENT BUILDING AT  
ALBERTON CAMPUS**

ASSESSMENT AND CONSULTATION REPORT

07 April 2017

**PREPARED FOR:**  
SARS ALBERTON  
49 McKinnon Crescent,  
New Redruth  
Alberton  
Johannesburg  
1892

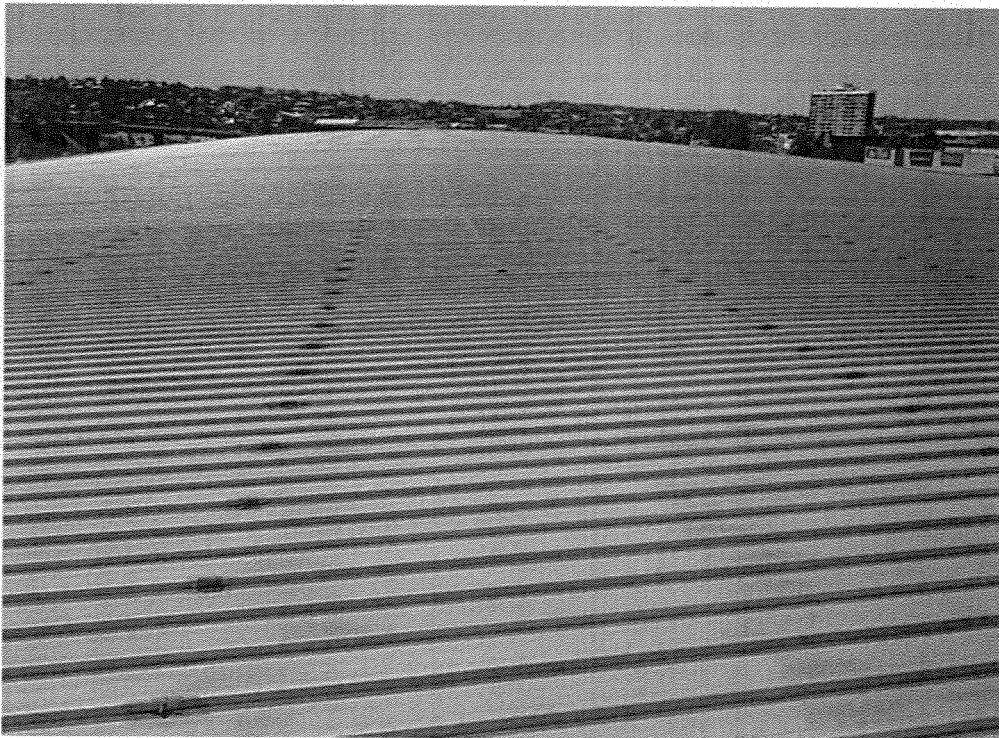
Existing Klip-lok roofing sheet at assessment building

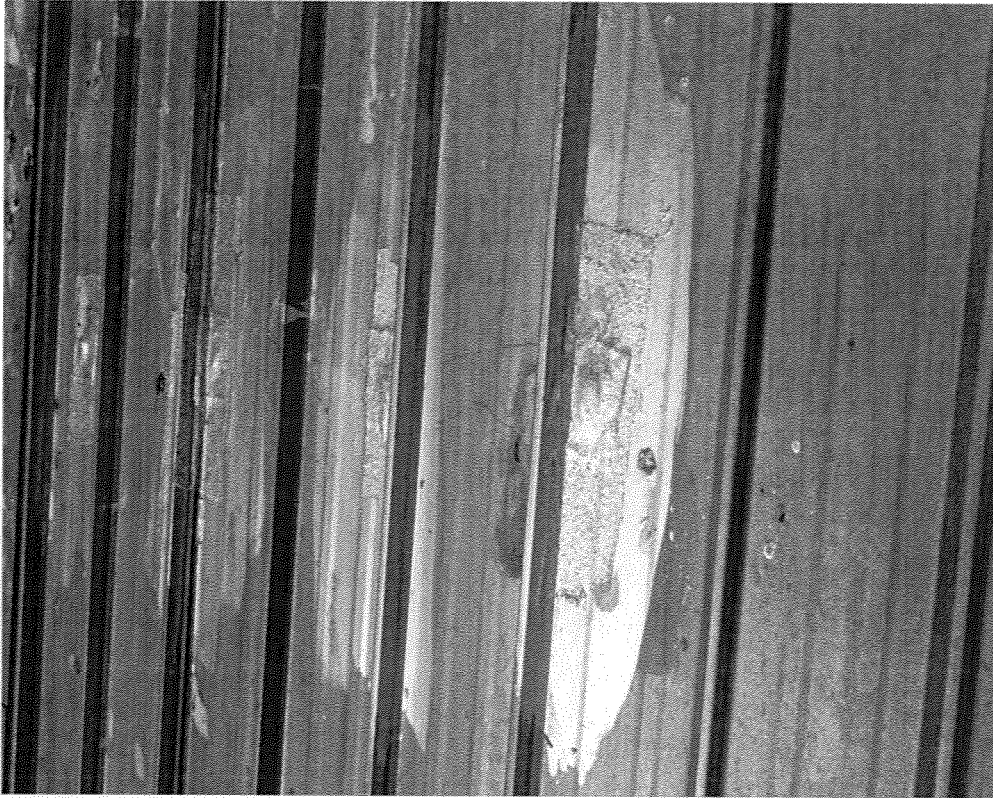
Existing roof patching

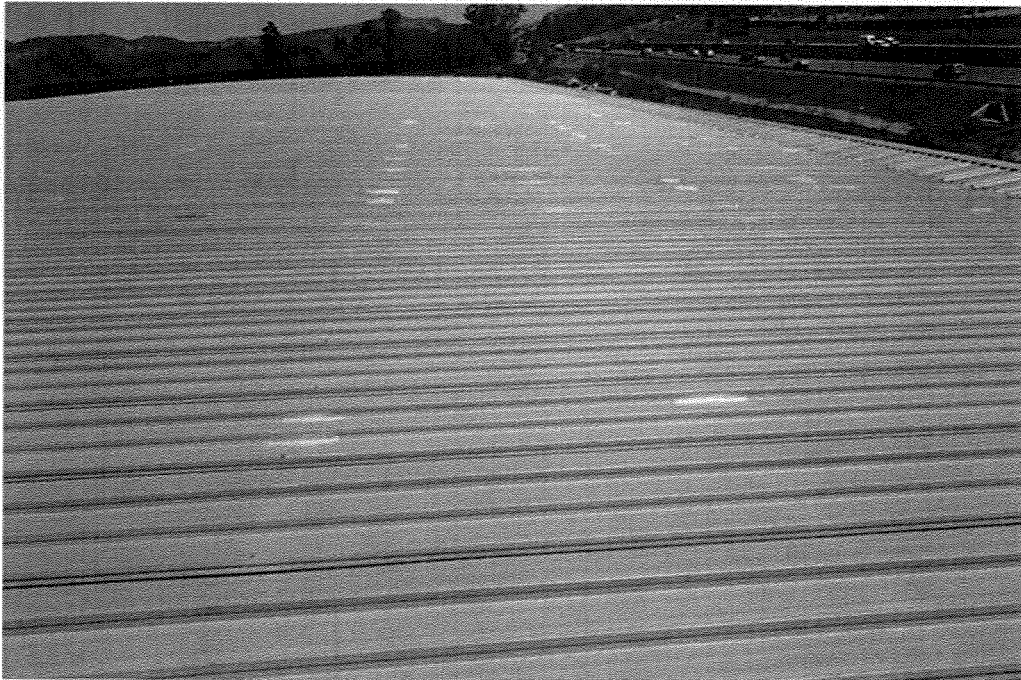
Visible silver coat paint applied over patched areas

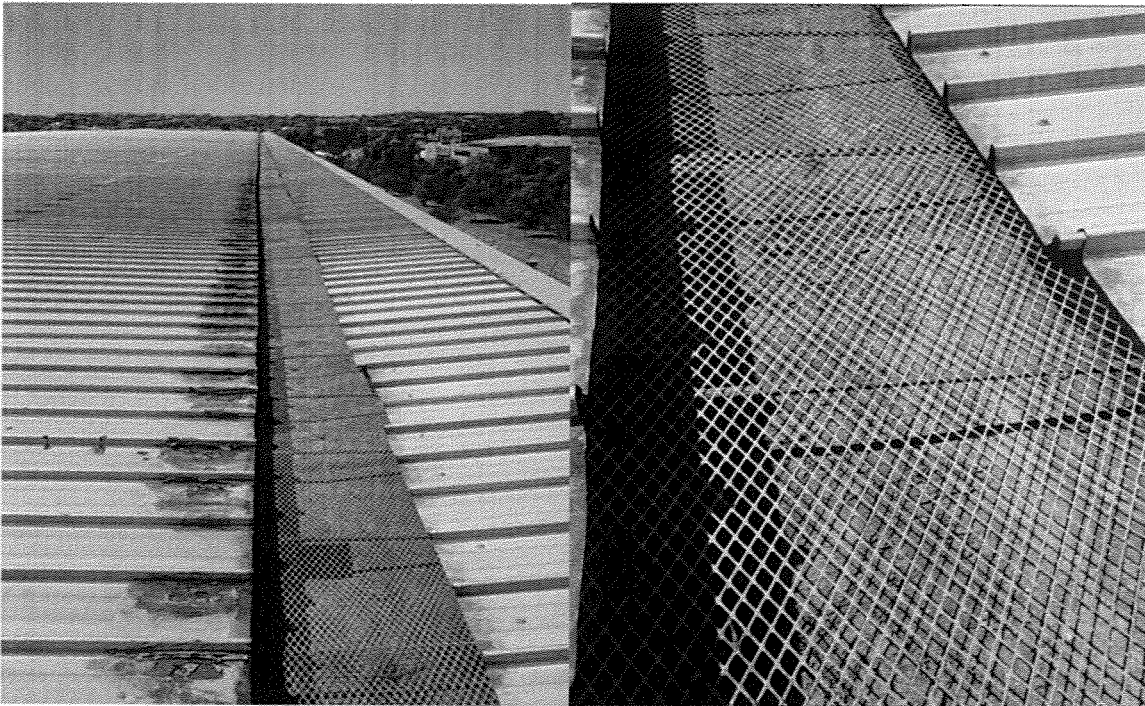
Steel box gutter blocked with mud and debris. Take out expanded mesh cover, clean gutters and downpipes off mud and debris, recondition expanded mesh and secure back to the box gutter. The client is advised to do periodic cleaning of rainwater goods after the cleaning as access to roof will be provided as part of the assignment.
