**ASSESSMENT REPORT FOR DRAFTING OF
BOQ FOR THE REPAIRS OF PERMANENT ROOF LEAKS FOR THE
ENFORCEMENT BUILDING AT
ALBERTON CAMPUS**

ASSESSMENT REPORT

07 April 2017

PREPARED FOR:
SARS ALBERTON
49 McKinnon Crescent,
New Redruth
Alberton
Johannesburg
1892

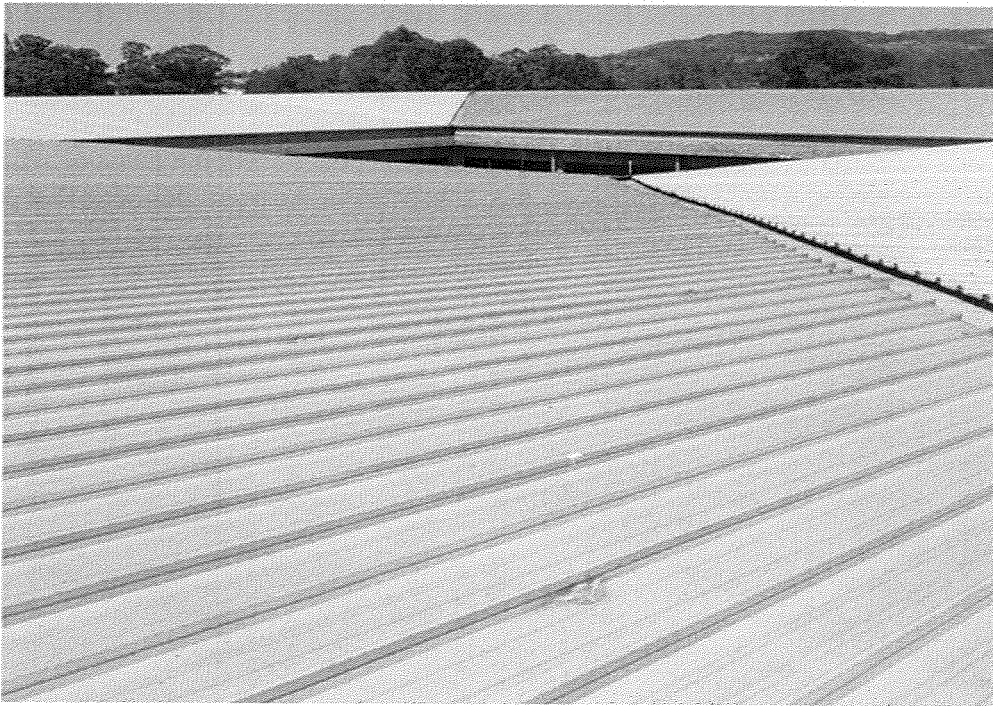
Existing Klip-lok roofing sheet at Enforcement building

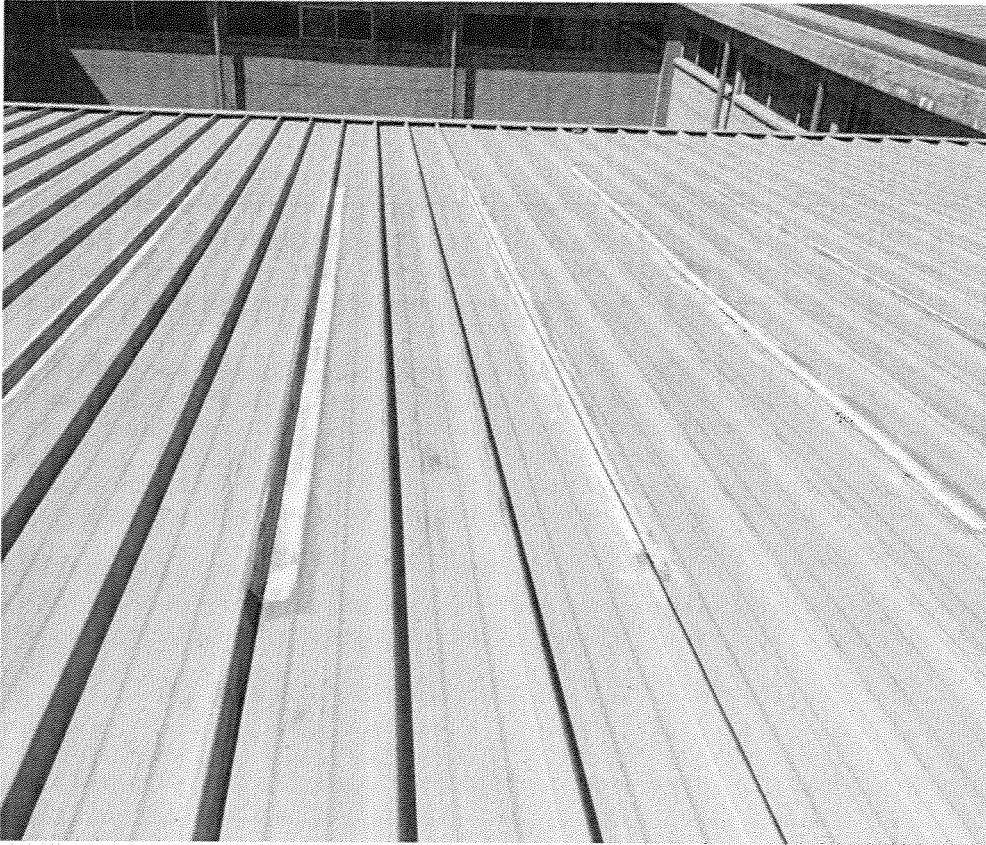
Existing roof patching

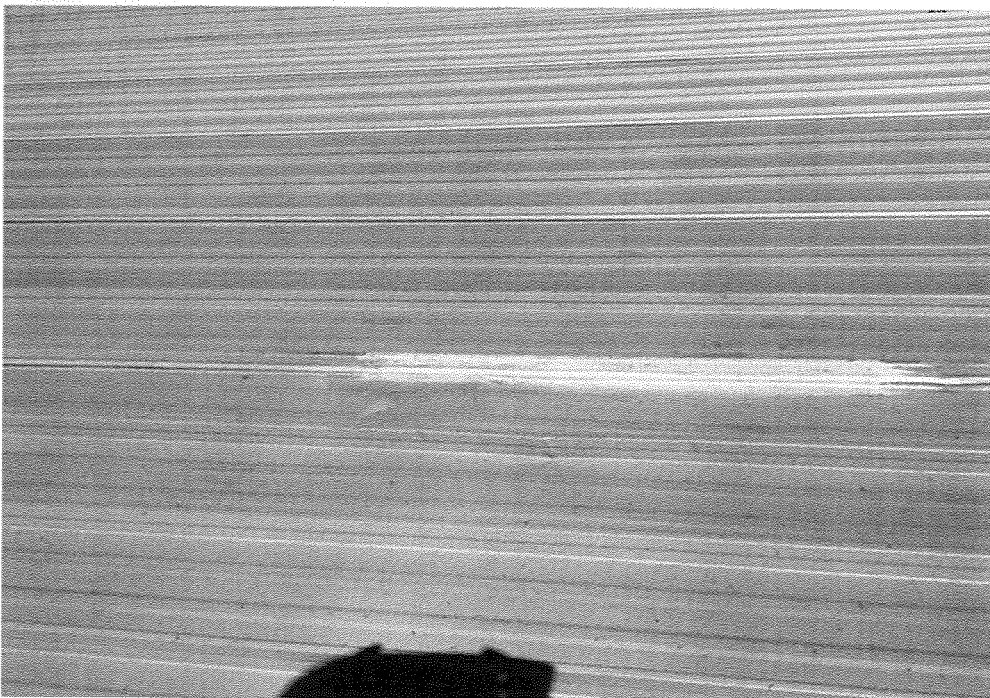
Visible silver coat paint applied over patched areas

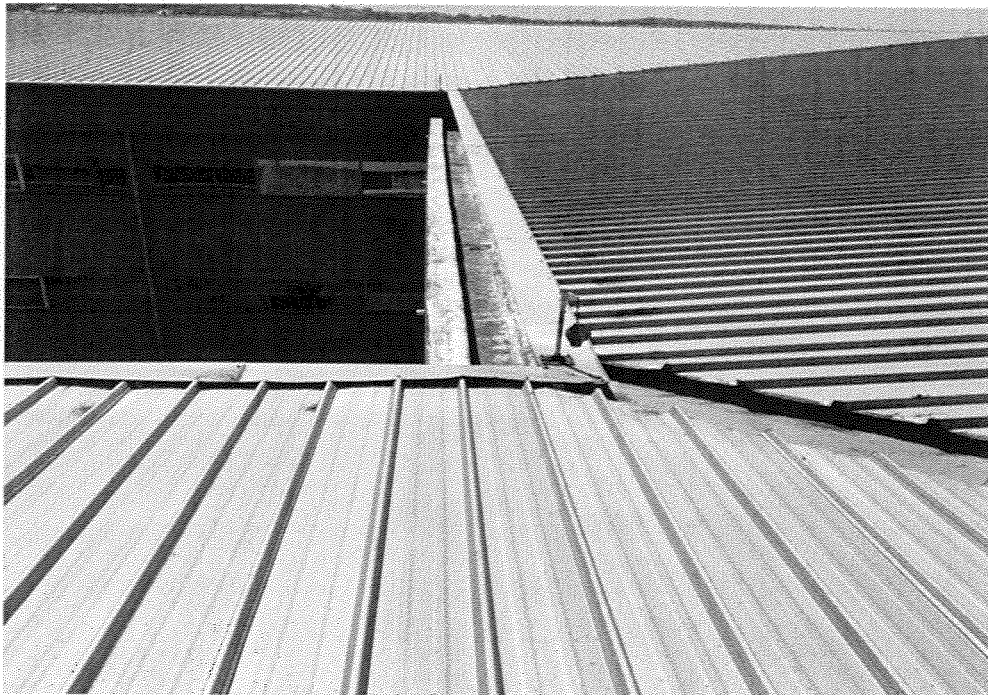
Concrete box gutter blocked with mud and debris. Clean gutters and downpipes off mud and debris and make good waterproofing where damaged. The client is advised to do periodic cleaning of rainwater goods after the cleaning as access to roof will be provided as part of the assignment.
